Unclassified **NEA/CSNI/R(2017)3**

NUCLEAR ENERGY AGENCY
COMMITTEE ON THE SAFETY OF NUCLEAR INSTALLATIONS

Operating Experience Insights into Pressure Boundary Component Reliability and Integrity Management

Topical Report by the Component Operational Experience, Degradation and Ageing Programme (CODAP) Group

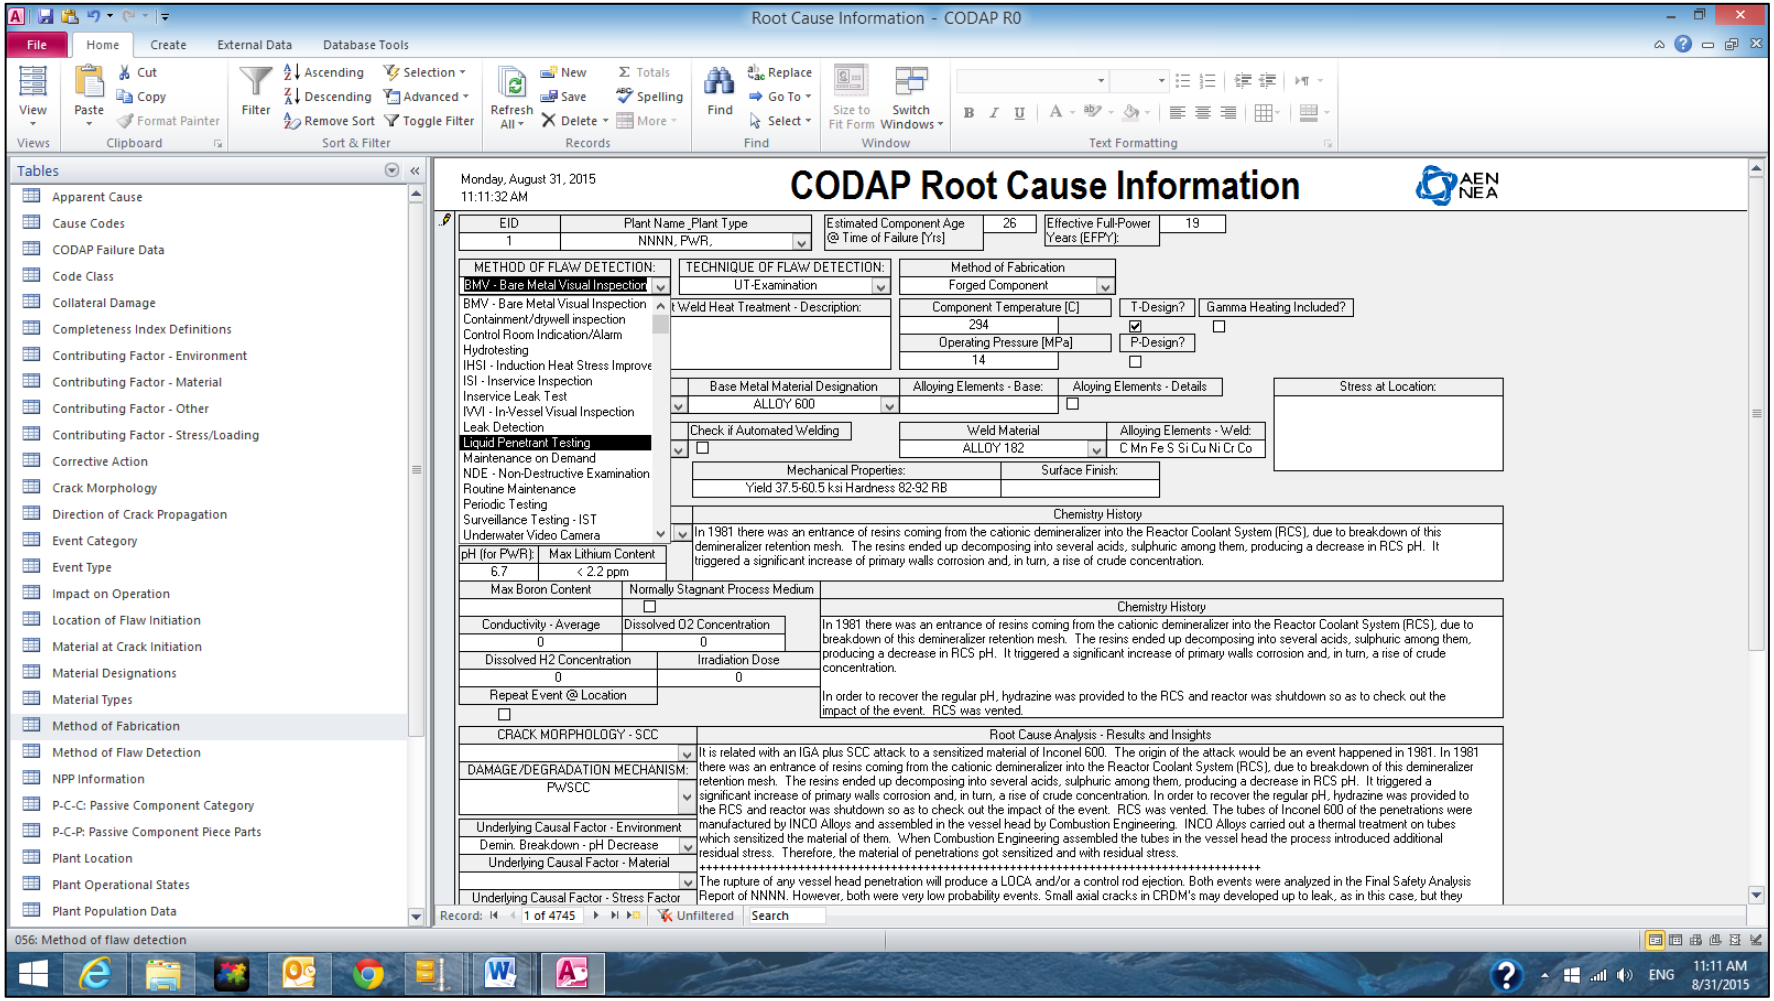
Illustrated in Figure 1 is an example of how method of flaw detection is classified in the database. The given example is concerned with the discovery in 1994 of a degraded pressurised water reactor (PWR) pressure vessel head penetration during a scheduled bare metal visual examination (BMV).

Underlying Causal Factor - Stress Factor
Root Cause Analysis - Results and Insights
It is related with an IGA plus SCC attack to a sensitized material of Inconel 600. The origin of the attack would be an event happened in 1981. In 1981 there was an entrance of resins coming from the cationic demineralizer into the Reactor Coolant System (RCS), due to breakdown of this demineralizer retention mesh. The resins ended up decomposing into several acids, sulphuric among them, producing a decrease in RCS pH. It triggered a significant increase of primary walls corrosion and, in turn, a rise of crude concentration. In order to recover the regular pH, hydrazine was provided to the RCS and reactor was shutdown so as to check out the impact of the event. RCS was vented. The tubes of Inconel 600 of the penetrations were manufactured by INCO Alloys and assembled in the vessel head by Combustion Engineering. INCO Alloys carried out a thermal treatment on tubes which sensitized the material of them. When Combustion Engineering assembled the tubes in the vessel head the process introduced additional residual stress. Therefore, the material of penetrations got sensitized and with residual stress.

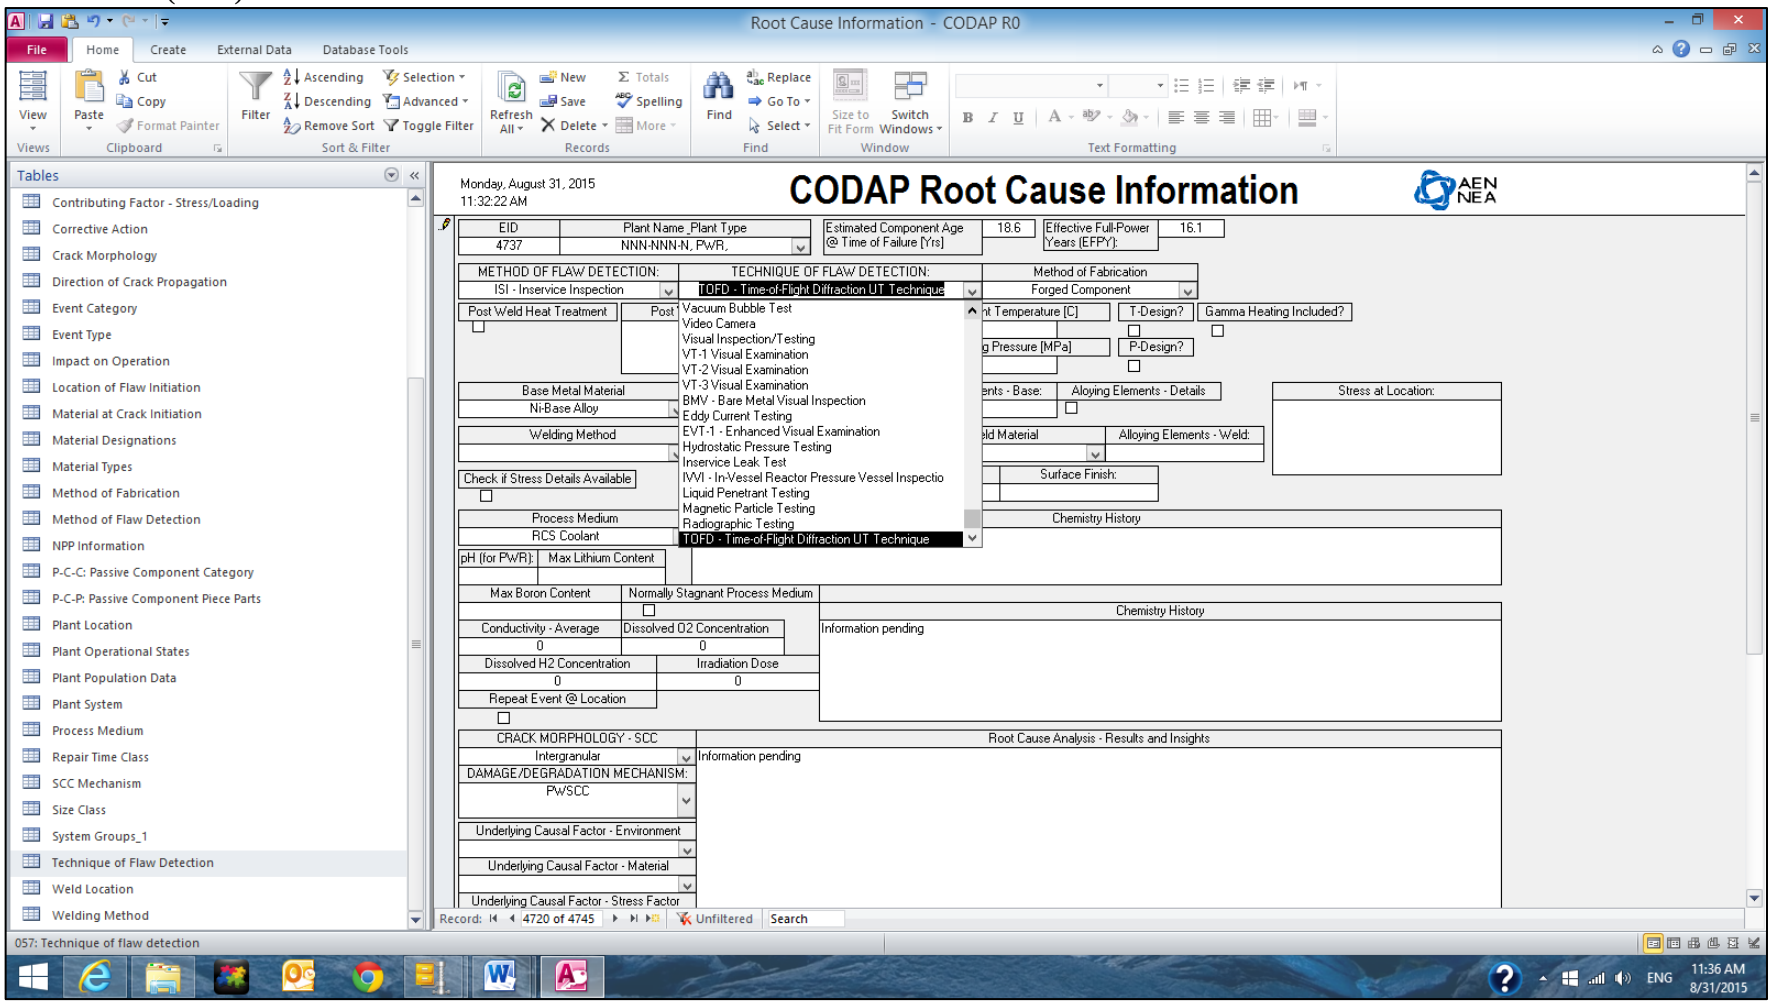
Figure 2: Technique of flaw detection

Illustrated in Figure 2 is an example of how technique of flaw detection is classified in the database. The given example is concerned with the discovery in 2013 of a degraded PWR pressure vessel head penetration during a scheduled BMV examination using Time-of-Flight Diffraction (TOFD) UT technology.

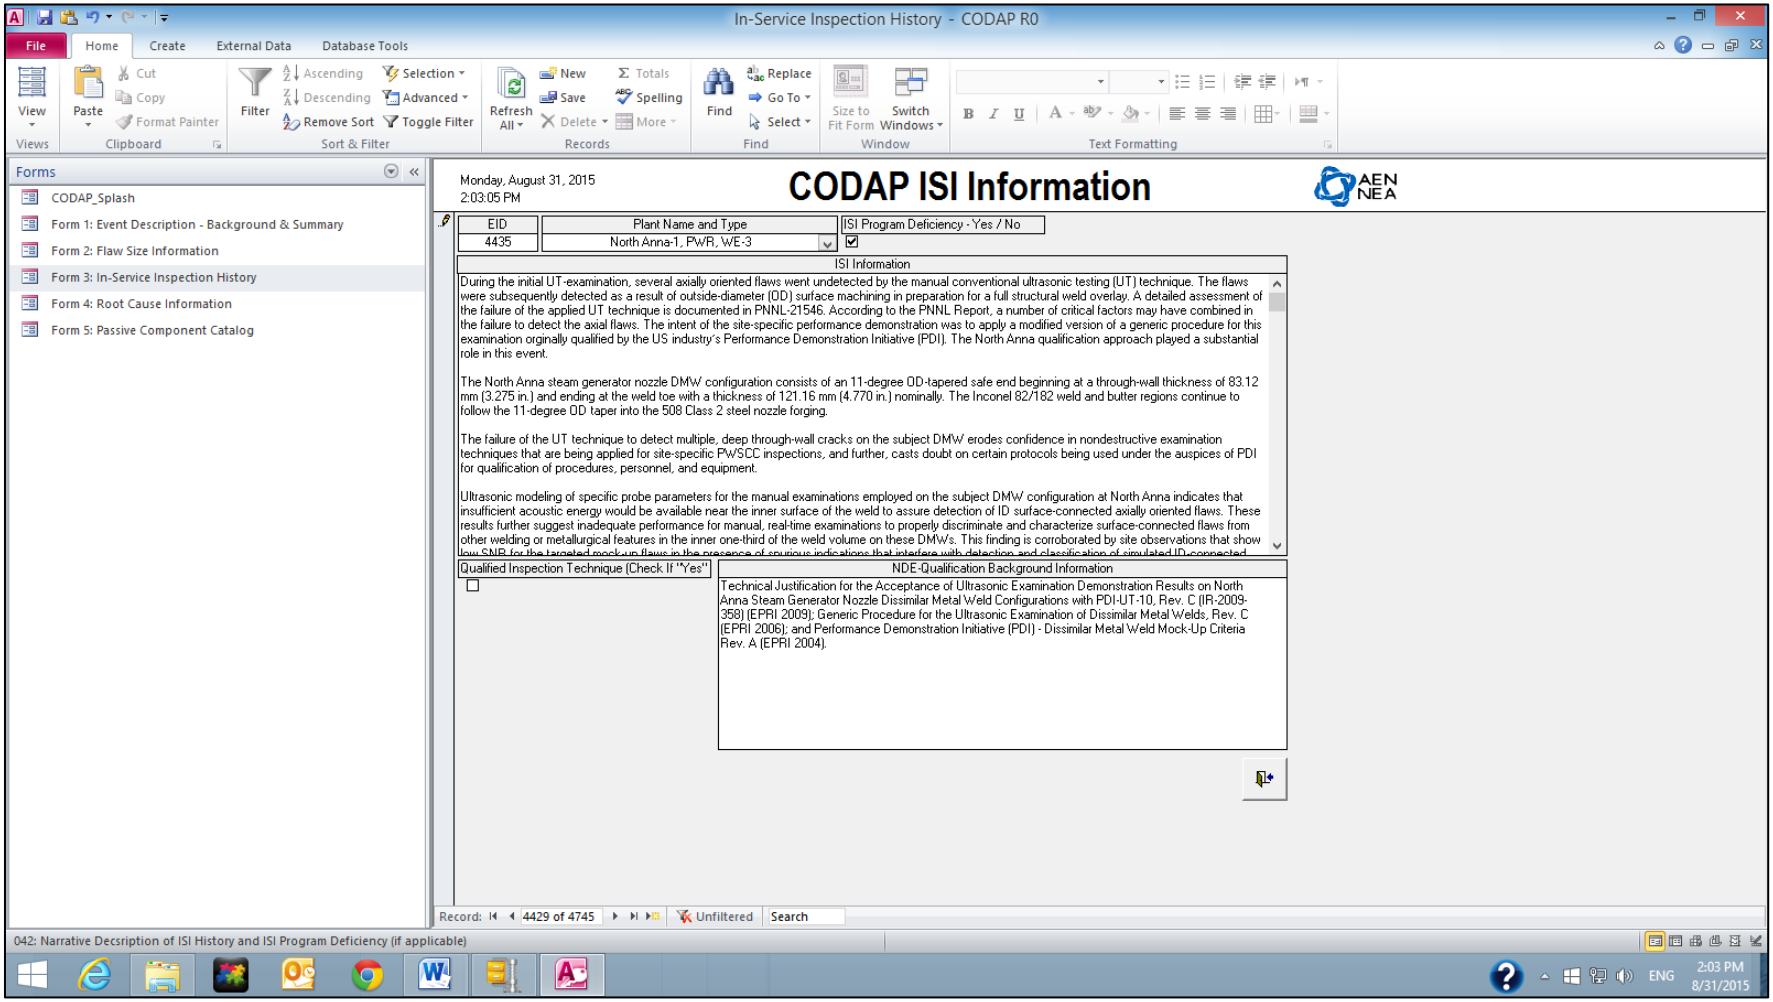
Figure 9: An example of failure of UT examination to detect a flaw

- Figure 9. During an ISI of a dissimilar metal weld in a reactor coolant system hot leg inlet to a SG nozzle at a US PWR, several axially oriented flaws went undetected by the manual conventional ultrasonic testing (UT) technique. The flaws were subsequently detected as a result of outside diameter (OD) surface machining in preparation for a weld overlay.
- Figure 10. During normal power operation a US PWR experienced a moisture separator reheater pipe rupture. The ruptured pipe was included in the owner's FAC Programme. However, an incorrect orifice opening size had been entered into the FAC prediction software, which caused the software to incorrectly calculate the pipe wall wear rate. Based on the calculated results the failed pipe had not been subject to any volumetric examination.

2:03:05 PM
CODAP ISI Information
AEN NEA
EID
4435
Plant Name and Type
North Anna-1, PWR, WE-3
ISI Program Deficiency - Yes / No
ISI Information
During the initial UT-examination, several axially oriented flaws went undetected by the manual conventional ultrasonic testing (UT) technique. The flaws were subsequently detected as a result of outside-diameter (OD) surface machining in preparation for a full structural weld overlay. A detailed assessment of the failure of the applied UT technique is documented in PNNL-21546. According to the PNNL Report, a number of critical factors may have combined in the failure to detect the axial flaws. The intent of the site-specific performance demonstration was to apply a modified version of a generic procedure for this examination orginally qualified by the US industry's Performance Demonstration Initiative (PDI). The North Anna qualification approach played a substantial role in this event.

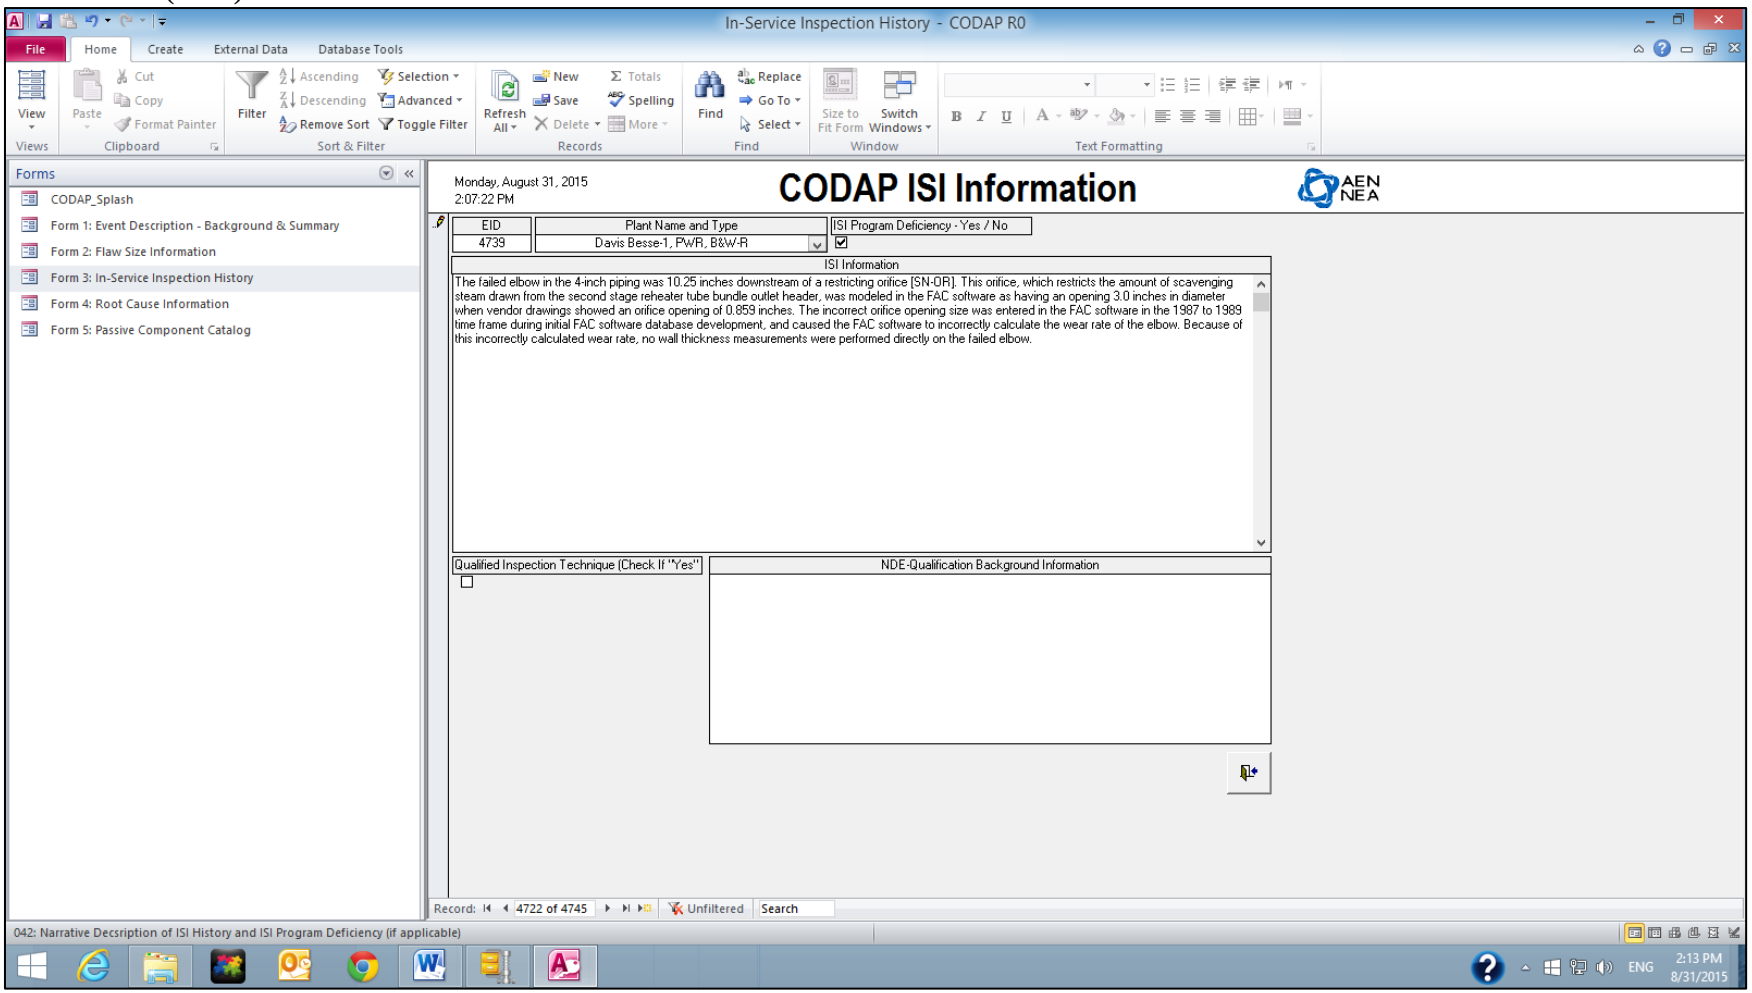
2:07:22 PM
CODAP ISI Information
AEN NEA
EID
4739
Plant Name and Type
Davis Besse-1, PWR, B&W-R
ISI Program Deficiency - Yes / No
ISI Information
The failed elbow in the 4-inch piping was 10.25 inches downstream of a restricting orifice [SN-OR]. This orifice, which restricts the amount of scavenging steam drawn from the second stage reheater tube bundle outlet header, was modeled in the FAC software as having an opening 3.0 inches in diameter when vendor drawings showed an orifice opening of 0.859 inches. The incorrect orifice opening size was entered in the FAC software in the 1987 to 1989 time frame during initial FAC software database development, and caused the FAC software to incorrectly calculate the wear rate of the elbow. Because of this incorrectly calculated wear rate, no wall thickness measurements were performed directly on the failed elbow.
Qualified Inspection Technique (Check If "Yes"
